# NASA CONTRACTOR REPORT

NASA CR-103

# 9½ FOOT DIAMETER MASTER AND MIRROR

Prepared by GENERAL ELECTRIC CO. under Contract No. 950239 for JET PROPULSION LABORATORY under Contract No. NAS 7-100 for

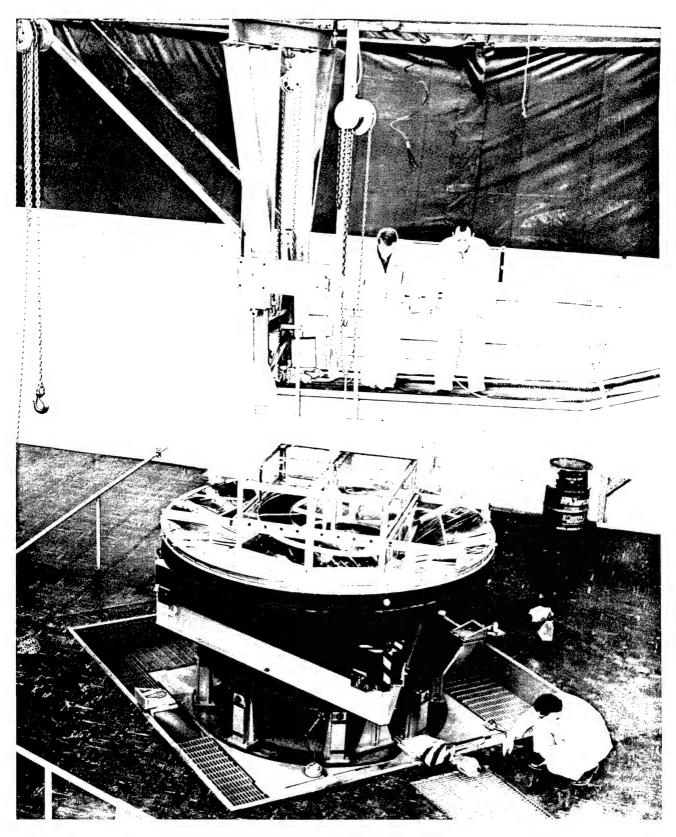
Figure 5.2-7. Spincasting of Pour No. 3

In order to prevent dust from settling on the cured surface, the first three coats were visually inspected through the cover. Some haze discoloration was observed on spincast coat Nos. 1 and 2 in the vicinity of the pouring chute periphery. The polypropylene cover made visual observation difficult, and the spiral chute also restricted visibility such that the geometrical pattern of the discoloration was not readily discernible. Pour No. 2 had faint radial lines around the outer periphery of the mold. In preparation for the third spincast coat, a second layer of polypropylene was used to cover the mold surface. Hardener soaked pads were placed between the two layers of the cover. It was thought that the cover was not completely air tight and the addition of a second layer plus the hardener pads would tend to improve the quality of the cast surface. A sketch and description of the spincast surface resulting from the third coat is shown in Figure 5.2-8.

Upon discovery of the third coat spincast surface imperfections, a conference of all the people at GE-MSD who were connected with the present and experienced with previous spincast fabrications was convened in order to determine the cause for these imperfections. After review of a large list of possible causes had been made, the following four possibilities remained.

### The corrective action taken was:

- 1. The polypropylene cover was replaced by a cover made of highly transparent plexiglass sheets bonded to an aluminum frame.
- 2. The pouring chute was eliminated and the epoxy was poured directly from the mixing machine through a long tube into the mold. (See Figure 5.2-9.)

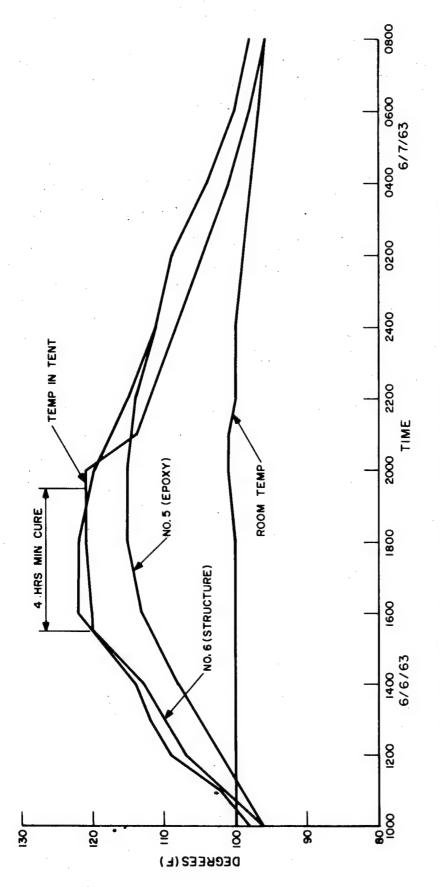
Figure 5.3-2. Temperature Recorded During Thermal Cure of Pour No. 8

Prior to thermal curing, thermocouples were placed in the epoxy and on the master support structure in various locations (Figure 5.3-1). Recorded temperatures from two of these thermocouples are shown in Figure 5.3-2. The thermocouples plotted represent the low and high values of temperatures which existed during the cure cycle. As can be seen from the Figure, a maximum difference of less than ten degrees existed between a point on the structure (No. 6) and a point in the epoxy (No. 5). The No. 6 thermocouple was located on the underside of the structure near the outside of the dish.

During the heating phase of the thermal cure cycle, two sharp cracking noises were heard. Visual inspection immediately after each of these noises did not disclose any damage. During the scribing operation (Appendix D) which was performed subsequent to the second optical inspection, the scribing tool did not continuously cut into the surface, but missed it over part of a full revolution. During the final stages of scribing and three days after it had been cooled to room temperature the spincast mold cracked as shown on the pattern in Figure 5.3-3. A close-up of the cracked area is shown in Figure 5.3-4. The area between the two cracks, approximately one-quarter of the total mold area, lifted up from the aluminum support structure a distance of approximately 5/16 of an inch (Figure 5.3-5). A portion of the cracked spincasting after removal from the aluminum dish is shown in Figure 5.3-6.

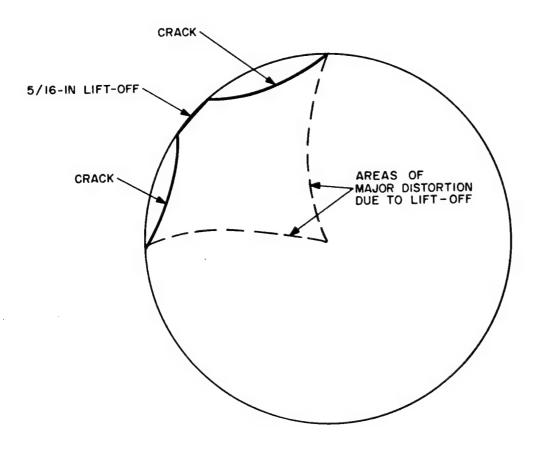
Figure 5.3-3. Pattern of Cracked Mold

It is believed that the thermal cure cycle caused shear stresses between this exceptionally thick spincast epoxy mold and its aluminum back-up structure which exceeded the bond strength between the two materials. The above-mentioned cracks heard during the cure probably indicated the occurrence of shear separation. The mold, however, continued to be held down to its support structure by the bending strength of the plastic which bridged the separated areas. The drop in temperature to as low as 74°F and the mechanical shock caused by intermittent scribing were instrumental in triggering the cracking of the mold, but were not the actual causes of it.

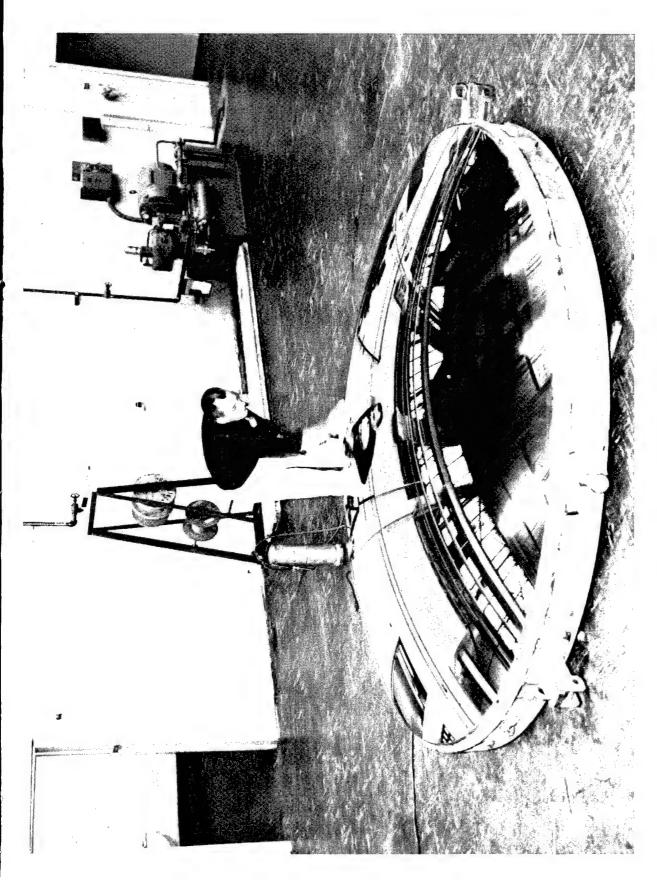
Figure 6.5-4. Wiping of Male Master

The surface texture had a slight "orange peel" appearance, resulting from replication of the mating epoxy surface, which was affected by the removal of the first faulty silvered layer described in Section 6.1.2. An attempt was made to eliminate this effect by wiping with a special French cotton (Figure 6.5-4). This procedure was only partially successful.

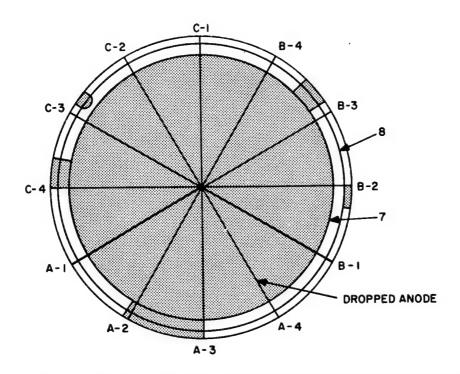
Figure 7.4-1. Mirror Regions Where Reticle Readings Could not be Obtained (Non-Shaded Areas)

The mirror areas lying outside the reticle inspection limits are indicated by blank spaces in Figure 7.4-1. This Figure gives a graphical interpretation of the location of mirror areas with slope errors in excess of approximately 6 minutes.
